PREPARED BY THE U. S. ARMY BOARD FOR AVIATION ACCIDENT RESEARCH, FORT RUCKER, ALABAMA

OV-1 ACCIDENT SUMMARY

1 July 1966 through 30 June 1967

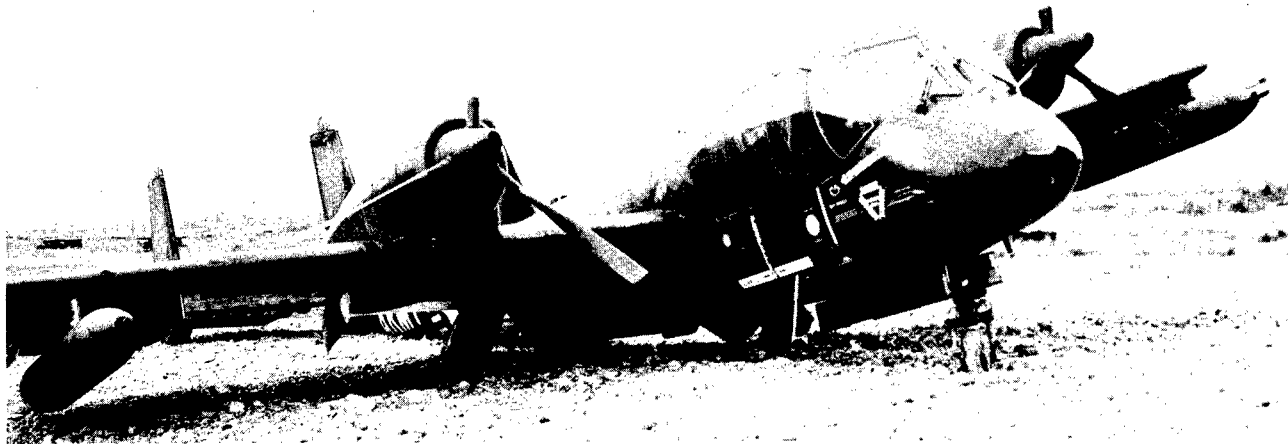
G922

G922—A VFR landing was attempted in poor visibility and heavy rain. GCA equipment was inoperative. Pilot made 360° turn 3 miles out on right base to let helicopter land. Forward visibility was zero and pilot lost sight of runway. Looking outside and using familiar ground references, pilot turned final. When runway was sighted, aircraft was off center and high. He made 180° turn and entered on left downwind for runway. Pilot told tower he was turning final with gear and pressure, and attempted to line up with runway by looking out the side. Tower would not clear aircraft for landing because of poor visibility. Pilot, thinking he had only 20 minutes of fuel left and that weather would get worse, continued on final. He sighted runway and thought he was at approach end, but he was actually about 1,800 feet out. Aircraft touched down with full flaps and swerved left, then skidded right before control was regained. Runway was 6,000 feet of PSP. Only 3,000 feet were available due to resurfacing. There was not enough room to go around. One piece of PSP was not interlocked with the adjoining piece, and protruded, causing all three gears to hang as aircraft crossed with brakes locked. Aircraft hit construction area and gear collapsed. Damage was so extensive that only the engines could be salvaged. Caused by attempting to remain VFR in IFR conditions. Other factors were weather, improperly installed PSP, and lack of overrun.
